## OBJECTIVES

## INCIDENT BACKGROUND

## INVESTIGATION AND DAMAGES

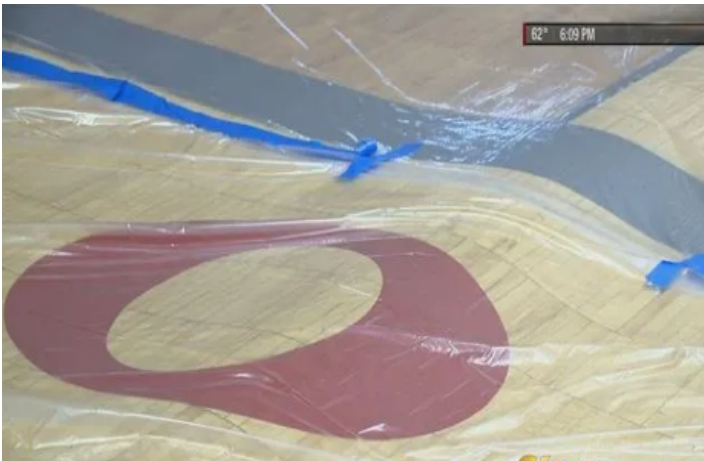
The member entered into a contract with a third-party contractor; a plumbing company, to complete renovations of several restrooms and shower areas within the high school. After completing work on the date of the loss, one of the bathroom's newly installed supply lines became disconnected and caused water to flow freely overnight. While the morning custodial staff conducted their daily walk through they noticed significant water present over the gym floor. Once the source of the water leak was identified and turned off they began trying to dry out the gym floor. After several hours it was observed that the gym floor had significant bowing, curling, and warping; making the gym unusable.

- After only a brief period of time of observation the plumber left for the day without turning off the main water supply.
- At some point after the plumber left and school was emptied, one of the fittings failed, and since the water supply was not turned off, the water was allowed to flow freely until the morning.

- It was determined that the fitting failed because it was not properly inserted and the pressure of the water supply forced the joint apart.

- Consider utilizing the services of CIRMA’s Contract program prior to signing and executing third-party agreements.
- Remove / amend “waiver of subrogation” language from agreements prior to signing.
- Utilize the CIRMA Risk Management Best Practices Guide on Risk Transfer as a reference when creating and drafting third-party agreements.
